# Minatrea Inspection

## INSPECTION REPORT

# 7107 Teaberry Dr

Austin TX 78745

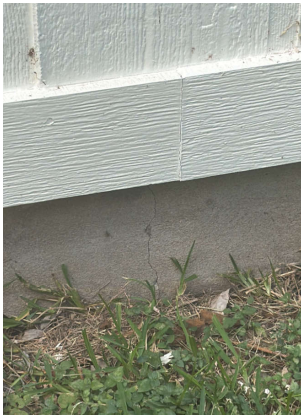
**Deficient Foundation Cracking**

Cracking observed in foundation walls or slab. Narrow vertical or diagonal cracks are typically shrinkage or minor settlement. Horizontal cracks, stair-step cracks in block walls, and displaced cracks suggest movement and warrant engineer review. Photograph and measure to track any progression.

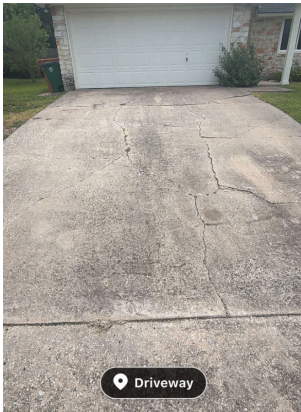
**Deficient Driveway Cracking or Heaving**

Driveway surface shows significant cracking, heaving, or settling. While primarily cosmetic, severe cracking near the garage can direct water toward the foundation. Seal cracks and monitor; plan for resurfacing or replacement.

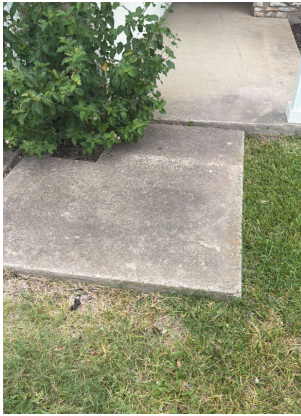
**Deficient Trip Hazards at Hardscape**

Displaced sections of driveway, walkway, or patio create trip hazards. Options include mud-jacking, grinding, or panel replacement.

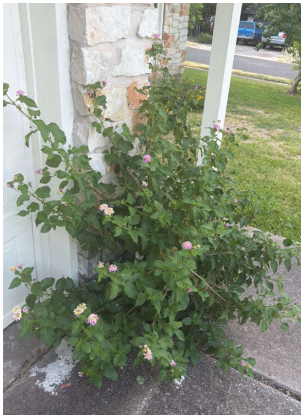
**Deficient Vegetation Affecting Structure**

Vegetation is in contact with the exterior cladding, or tree branches overhang or abrade the roof. This traps moisture, conceals pest activity, and damages finishes. Maintain at least 12 inches of clearance at siding and 6 feet above the roof.

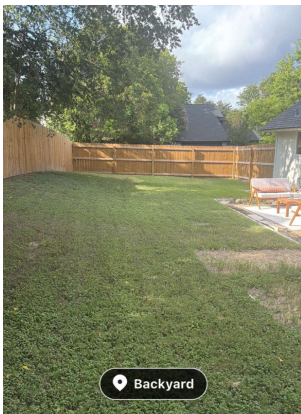
[Backyard](#)

**Deficient Grading Directs Water Toward Home**

Ground surface slopes toward the foundation in one or more locations. Persistent water contact is the leading cause of foundation moisture, wall cracking, and slab movement. Regrade to achieve a minimum 6 inches of drop over the first 10 feet from the structure.

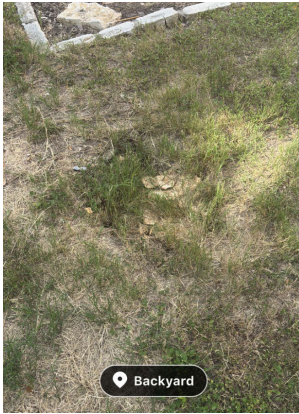
Backyard

An open hole was observed in the backyard, presenting a potential tripping hazard and safety risk. Recommend filling and properly leveling the affected area.

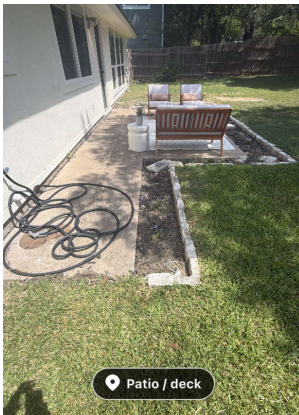
Patio / deck

**Grade Higher Than Back Porch**

The back porch surface is lower than the surrounding grade, creating a potential for water to pool against the foundation. Ground levels should be regraded or alternative drainage installed to direct water away from the structure and prevent potential moisture intrusion.

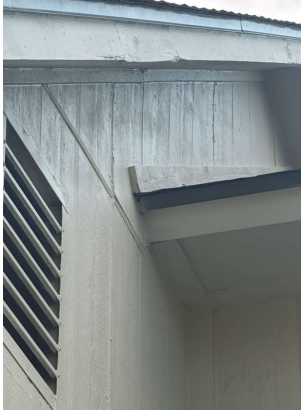
Kickout flashing is absent or improper where the roof meets a sidewall. Without a kickout flashing, water running down the wall is directed behind the cladding rather than into the gutter. Recommend installation.

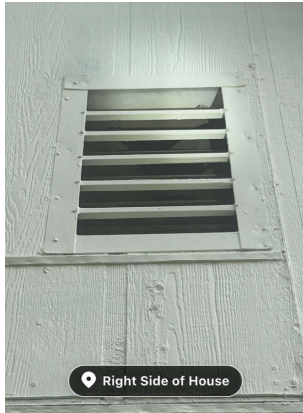
Gable-end vents are damaged, screened with inadequate mesh, or improperly installed. Damaged vents allow pest entry and moisture intrusion. Repair or replace with louvered, screened vents.

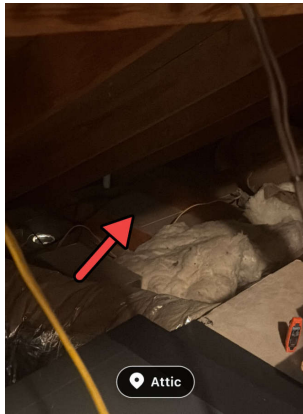
Attic

**Deficient Missing Insulation**

Insulation is absent or missing in areas of the attic. Gaps reduce thermal performance and may indicate prior water damage or pest activity. Add insulation to meet current energy standards.

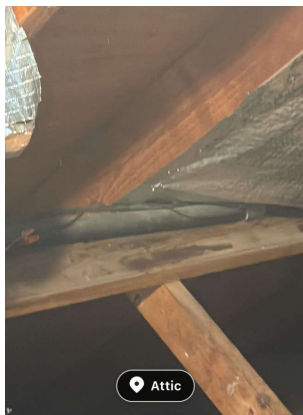
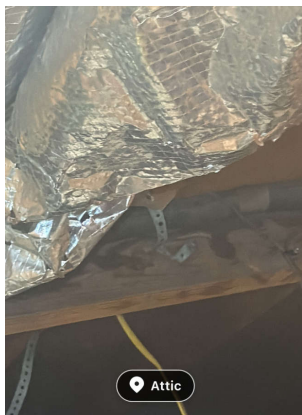
Attic

**Deficient Water Stains Under Condensate Line**

Water stains were observed in the attic beneath the HVAC condensate line. This condition indicates past or active leakage or condensate overflow. Recommend evaluation and necessary repairs by a qualified HVAC technician to ensure proper drainage and prevent moisture damage.

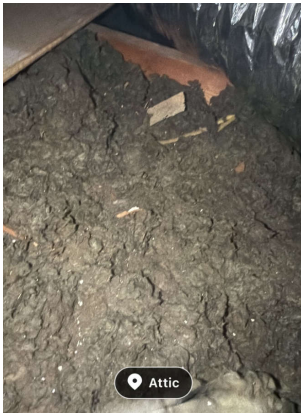
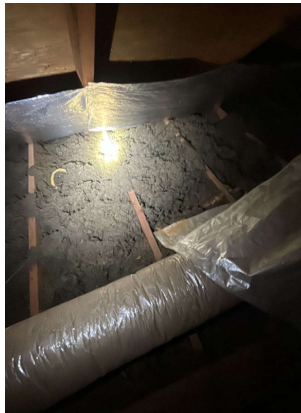
**Attic**

**Deficient** **Attic Insulation R-Value**

Attic insulation depth appears less than recommended for this climate zone. Current Department of Energy recommendations for Central Texas (Climate Zone 3) are R-38 to R-60. Recommend adding blown-in insulation to bring levels up to standard.

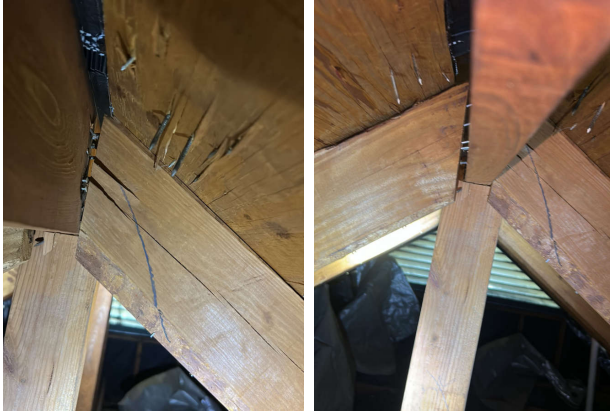
**Deficient Rafters Separated from Ridge Board**

Rafter boards were observed separated or not in full contact with the ridge board. Proper connection between rafters and the ridge board is necessary to ensure framing stability and structural support. Recommend evaluation and repair by a qualified structural contractor or engineer.

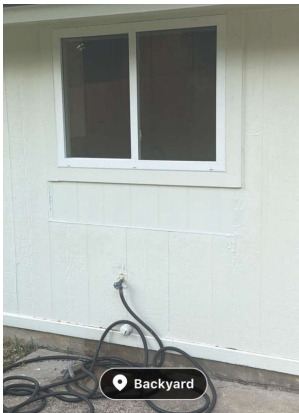
**Informational Evidence of Previous Siding Repair**
[Backyard](#)

Evidence of previous repairs was observed on the exterior siding at the backyard. Monitor the area for any signs of future moisture intrusion or deterioration, and consult with the seller for documentation regarding the repair history.

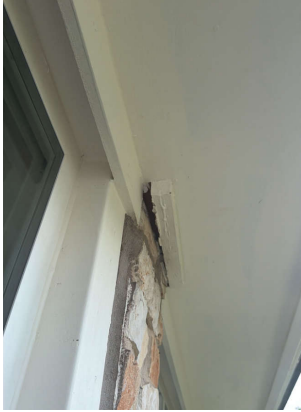
**Deficient Missing Frieze Board Sealant**

Sealant is missing behind the frieze board along the exterior trim. Sealant should be applied to prevent moisture intrusion and protect the underlying structure from water damage.

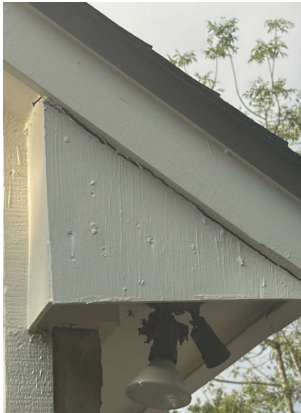
**Deficient** Fascia Board Sealant Separation

Sealant separation was observed at the fascia board on the front left exterior of the home. Damaged or separated sealants can allow water infiltration and localized deterioration behind the exterior trim. Recommend resealing the affected fascia joint to maintain a weather-tight exterior envelope.

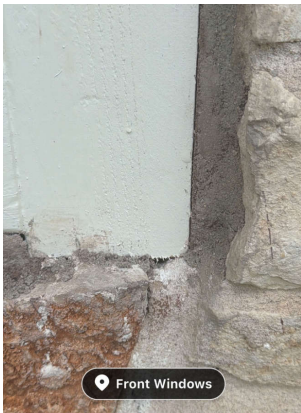
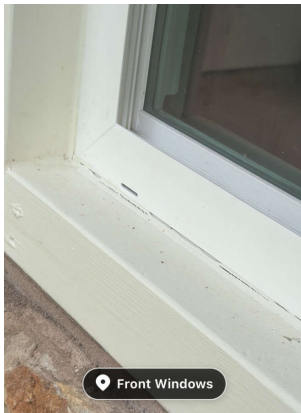
Front Windows

**Deficient** Exterior Caulking Deficiencies

Caulking at exterior penetrations, trim joints, or between dissimilar materials is cracked, missing, or failed. Caulk failures allow water and air intrusion. Remove failed caulk and replace with a paintable siliconized acrylic or urethane product.

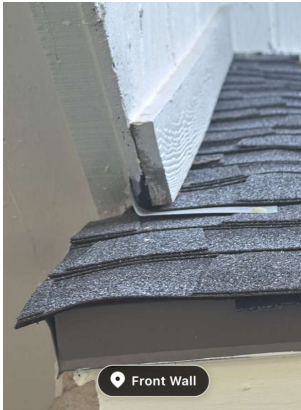
Front Wall

**Deficient Trim, Soffit, and Fascia Defects**

Defects observed in trim, soffit, or fascia: damage, rot, loose fastening, water staining at eaves, missing trim, open penetrations allowing pest entry, or paint failure.

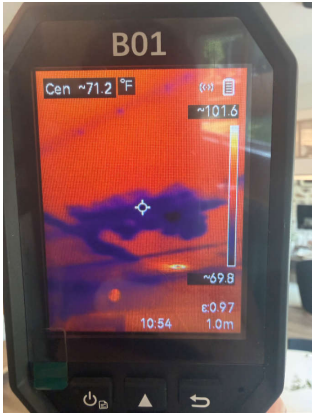
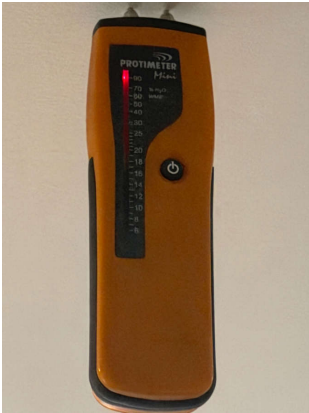
**Deficient Ceiling Water Stain**

Moisture and water staining were observed on the ceiling beneath the HVAC equipment. Staining indicates a past or present leak, likely related to HVAC condensate discharge or plumbing lines above. Recommend identifying and correcting the source of moisture and repairing or replacing damaged ceiling materials as needed.

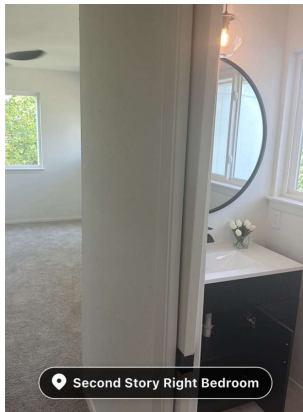
Second Story Right Bedroom

**Deficient Bathroom Door Off Track**

The interior door for the second story right bedroom bathroom is off its track, preventing proper operation. Repair or adjust the door hardware and re-align the door on its track to ensure smooth opening and closing.

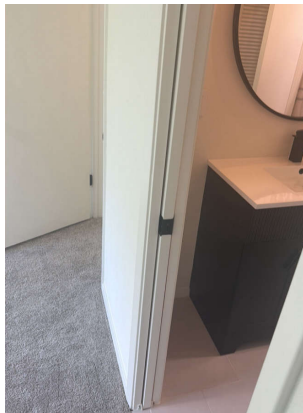
**Deficient Pocket Door Hard to Operate**

The pocket door to the bathroom in the second-story left bedroom is difficult to operate. The rollers and track should be repaired or adjusted to ensure smooth operation.

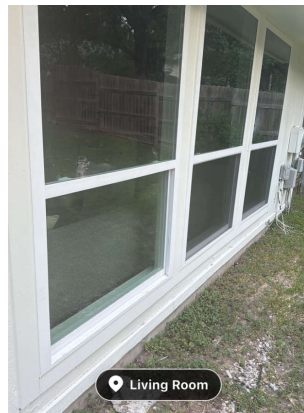
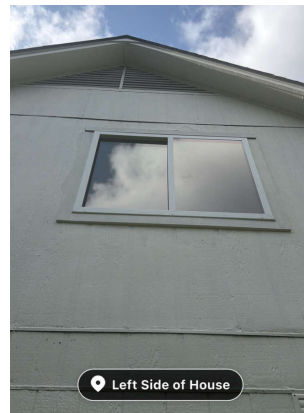
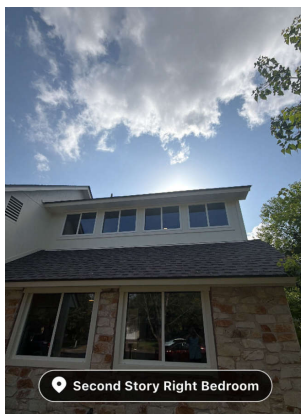
**Deficient** Window Screen Condition

Window screens are torn, missing, or damaged. Damaged screens allow insects to enter. Replace or repair screens.

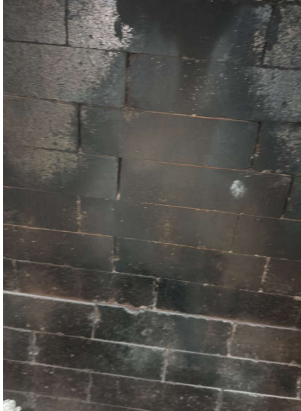
**Deficient Firebox and Hearth Defects**

Defects observed in the firebox or hearth: cracked firebrick, damaged mortar joints, damper inoperable or missing, hearth extension too short, combustibles too close, no spark screen or glass doors, or unsecured gas log set.

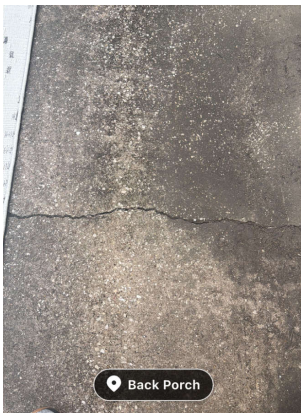
**Deficient Porch Concrete Cracking**

Cracking was observed in the concrete surface of the back porch. Seal cracks to prevent moisture intrusion and further deterioration, and monitor the area for progressive movement.

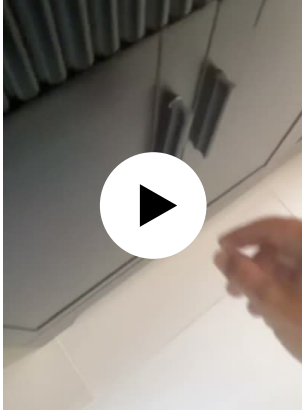
Second Floor Shared Bathroom

The cabinet handle in the second floor shared bathroom is loose. Tighten or repair the hardware as necessary to ensure proper function and prevent damage to the cabinet door/drawer.

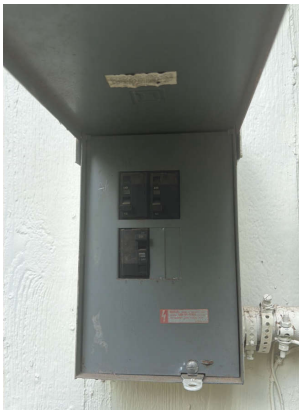
**Deficient Main Service Panel Unlabeled**

The main service panel breaker directory is missing, incomplete, or illegible. Proper labeling is necessary to allow safe and prompt isolation of individual circuits during maintenance or emergencies. Recommend having a qualified electrician properly identify and label all circuits.

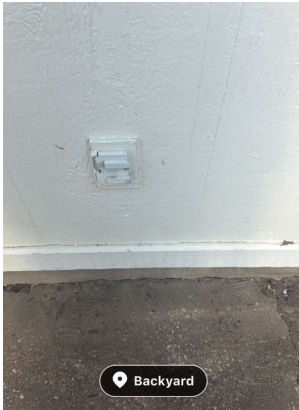
Backyard

**Deficient Exterior Outlet -- Missing Weatherproof Cover**

Exterior outlet lacks an in-use (bubble) weatherproof cover. Standard flip-covers are not rated for in-use protection. Replace with an in-use cover to protect connected cords.

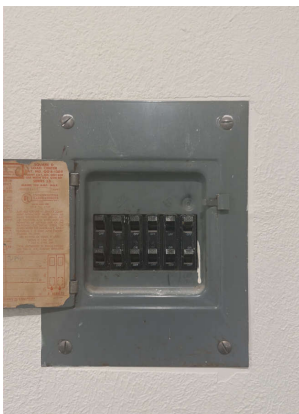
**Deficient Electrical Panel Label Accuracy**

Electrical panel breaker labels are incomplete, missing, or illegible. Accurate labeling allows safe isolation of circuits during maintenance. Recommend labeling all circuits with a licensed electrician.

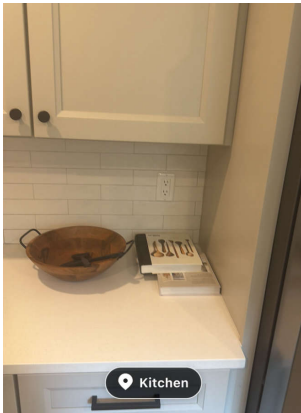
The kitchen receptacle is wired to the bathroom GFCI circuit. While GFCI protection is provided, branch circuits servicing bathrooms should be dedicated and not shared with kitchen outlets to prevent nuisance tripping and adhere to standard wiring practices. Recommend evaluation and correction by a qualified licensed electrician.

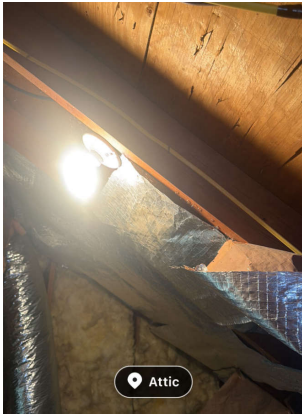
**Deficient Exposed Light Fixture in Attic** Attic

Exposed light bulbs or unshielded light fixtures were observed in the attic. Unprotected light fixtures pose an impact hazard and can create a potential fire risk if flammable materials come into contact with the hot bulb. It is recommended to install suitable protective guards or safety-rated light fixtures.

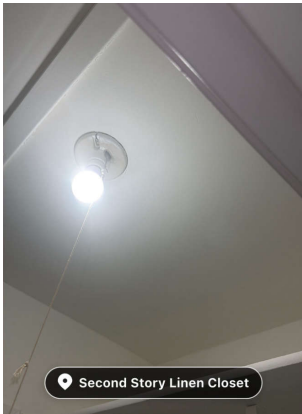
**Deficient Uncovered Bulb in Closet** Second Story Linen Closet

An uncovered light bulb was observed inside the second-story linen closet. Open or exposed light bulbs in closets present a fire hazard if combustible materials come into contact with the hot bulb. It is recommended to install a proper globe, shade, or enclosed fixture for safety.

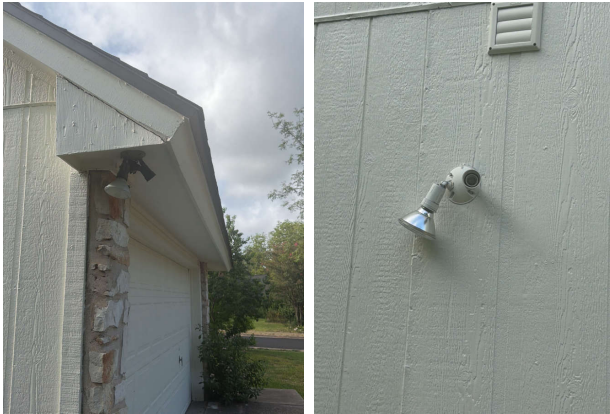
Outdoor light bulbs are missing from exterior light fixtures on the left side of the house. Recommend installing replacement light bulbs as needed for proper illumination and safety.

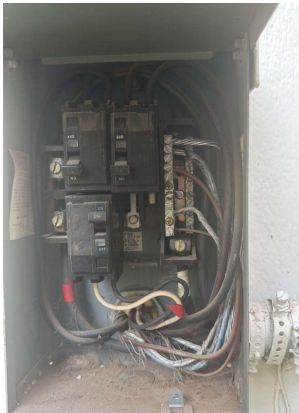
**Deficient Frayed Ground Wires**

Frayed ground wires were observed during the inspection. Damaged or frayed grounding conductors can compromise the safety and effectiveness of the electrical grounding system. A qualified licensed electrician should evaluate and repair as necessary.

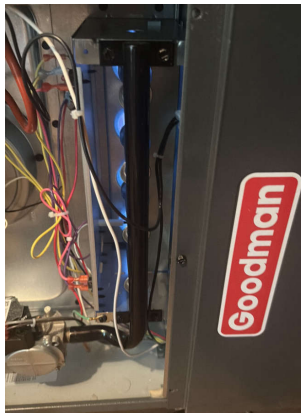
**Informational** Furnace Heating Operation

The furnace was tested and observed to be operating normally at the time of inspection.

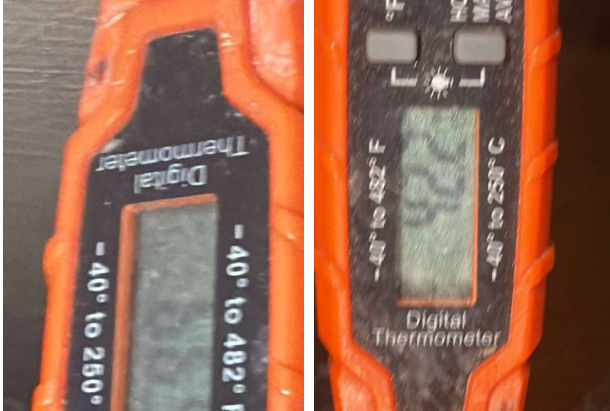
The air temperature differential between the return and supply plenums exceeded 22 degrees Fahrenheit. A high temperature split can indicate reduced airflow, dirty filters, or system performance issues. Recommend evaluation and servicing by a licensed HVAC contractor.

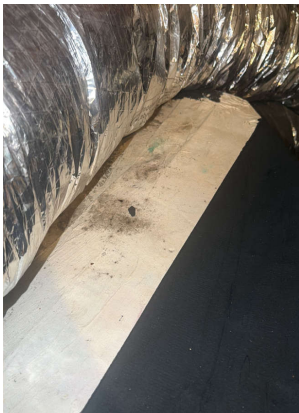
**Deficient Supply Plenum Condensate Accumulation**

Condensation was observed on top of the HVAC supply plenum, caused by loose or deteriorating sealant allowing air leakage. Recommend repairing and resealing the supply plenum connections to prevent moisture buildup and potential water damage.

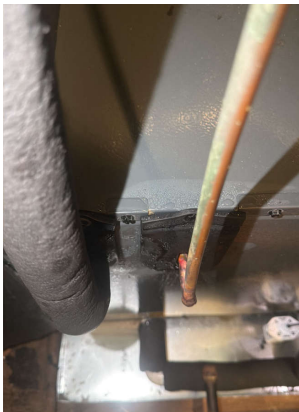
**Deficient Air Handler Cabinet Air Leaks**

The air handler cabinet was observed to be improperly sealed. Unsealed air handlers can draw in unconditioned air from unconditioned spaces (such as the attic or garage) or lose conditioned air, reducing efficiency and air quality. Recommend sealing all seams, joints, and penetrations at the air handler cabinet with approved mastic or foil tape by a qualified HVAC technician.

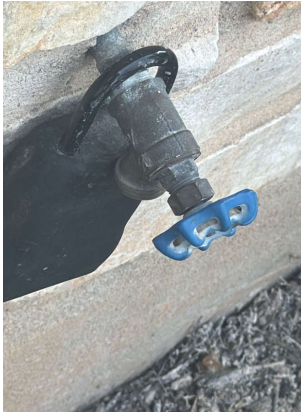
**Deficient Missing Backflow Protection on Outdoor Spigots**

Backflow prevention devices (vacuum breakers) were not installed on the outdoor hose bibbs/spigots. It is recommended to install anti-siphon vacuum breakers on all exterior spigots to prevent potential cross-contamination of the potable water supply.

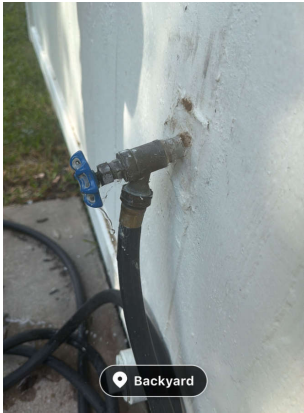
**Deficient Exterior Hose Bib Leak**[Backyard](#)

The exterior spigot located in the backyard was observed to be leaking. Leakage at outdoor plumbing fixtures can lead to water waste and potential erosion or moisture issues near the structure. A qualified plumber should evaluate and repair or replace the spigot as needed.

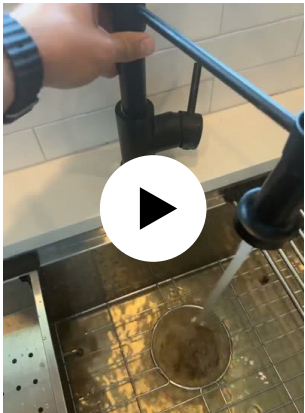
Deficient Loose Kitchen Faucet

The kitchen faucet is loose at its mounting base. Recommend securing the faucet fixture to the countertop or sink to prevent movement and potential leaks.

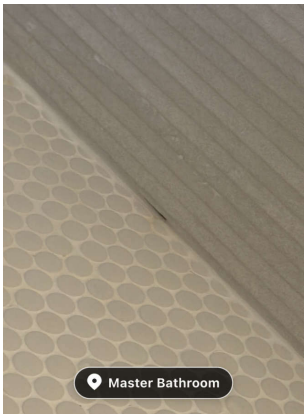
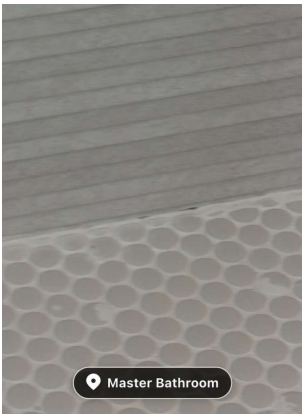
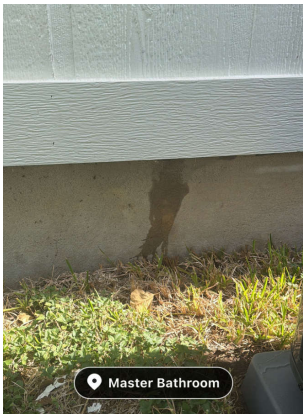
Deficient Tub or Shower Caulking Failed

Caulking at tub or shower tile perimeter is cracked, missing, or moldy. Failed caulk allows water to enter the wall cavity and damage framing. Remove old caulk and apply new 100% silicone caulk.

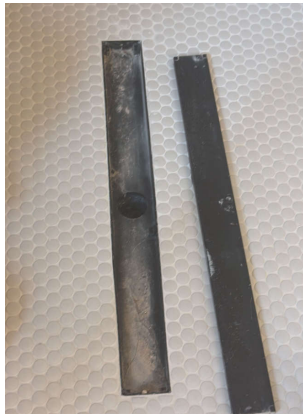
**Deficient Shower Drain Screen Missing**

The shower drain is missing its screen basket/strainer. A missing screen allows debris and hair to enter the drain lines, increasing the risk of clogs. An appropriate drain cover or strainer basket should be installed.

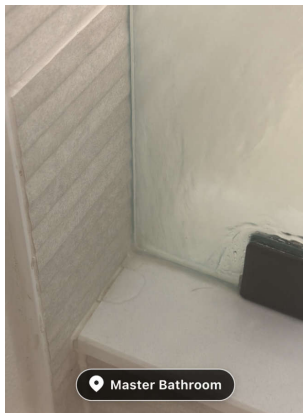
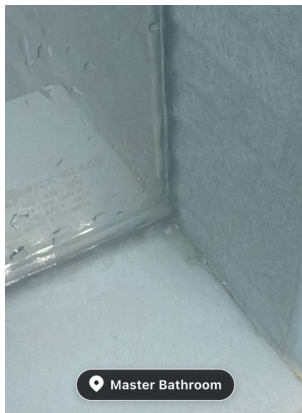
Master Bathroom

**Deficient Shower Enclosure Leaking**

The shower enclosure in the master bathroom was observed to be leaking. Recommend repair by a qualified professional to prevent concealed water damage to adjacent materials.

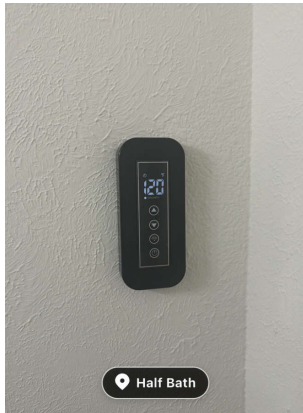
The thermostat/controller for the tankless water heater is located in the half bath.

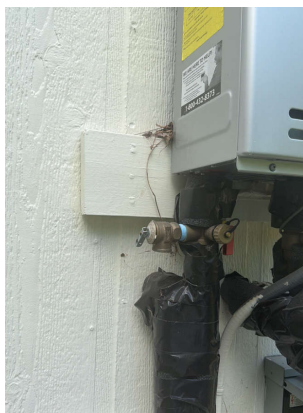
The discharge must terminate within 6 inches of the floor (or to the exterior), be the same diameter as the valve outlet, and have no valves or fittings that could restrict flow.

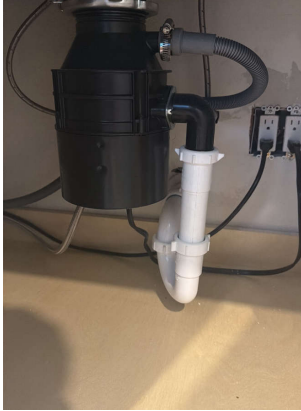
**Deficient Missing GFCI Protection for Disposal**

The food waste disposer (garbage disposal) is not GFCI protected as recommended/required. Recommend installation of GFCI protection for the disposal circuit by a licensed electrician.

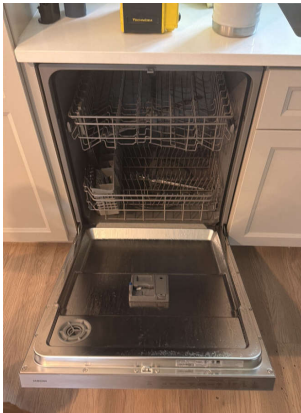
**Deficient Unsecured Dishwasher**

The dishwasher is not properly secured to the surrounding cabinetry or countertop. Secure the unit in accordance with manufacturer guidelines to prevent movement during operation.

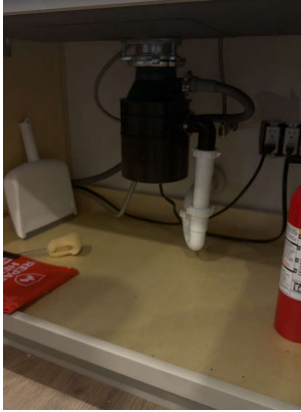
**Deficient Missing GFCI Protection - Dishwasher**

The dishwasher outlet or circuit lacks GFCI (Ground Fault Circuit Interrupter) protection. Current safety standards require GFCI protection for dishwasher circuits to mitigate electrical shock hazards. Recommend installation of GFCI protection by a licensed electrician.

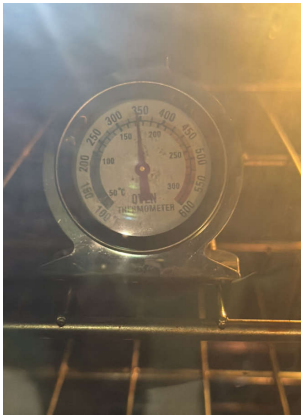
The oven heating elements were tested and determined to be operating adequately at the time of inspection.
